Water Compliance Inspection Report

**NPDES
Inspection Report**

**Pride & Joy Dairy #1
(NPDES Permit #: Unpermitted)**

Inspection Date: April 26, 2017

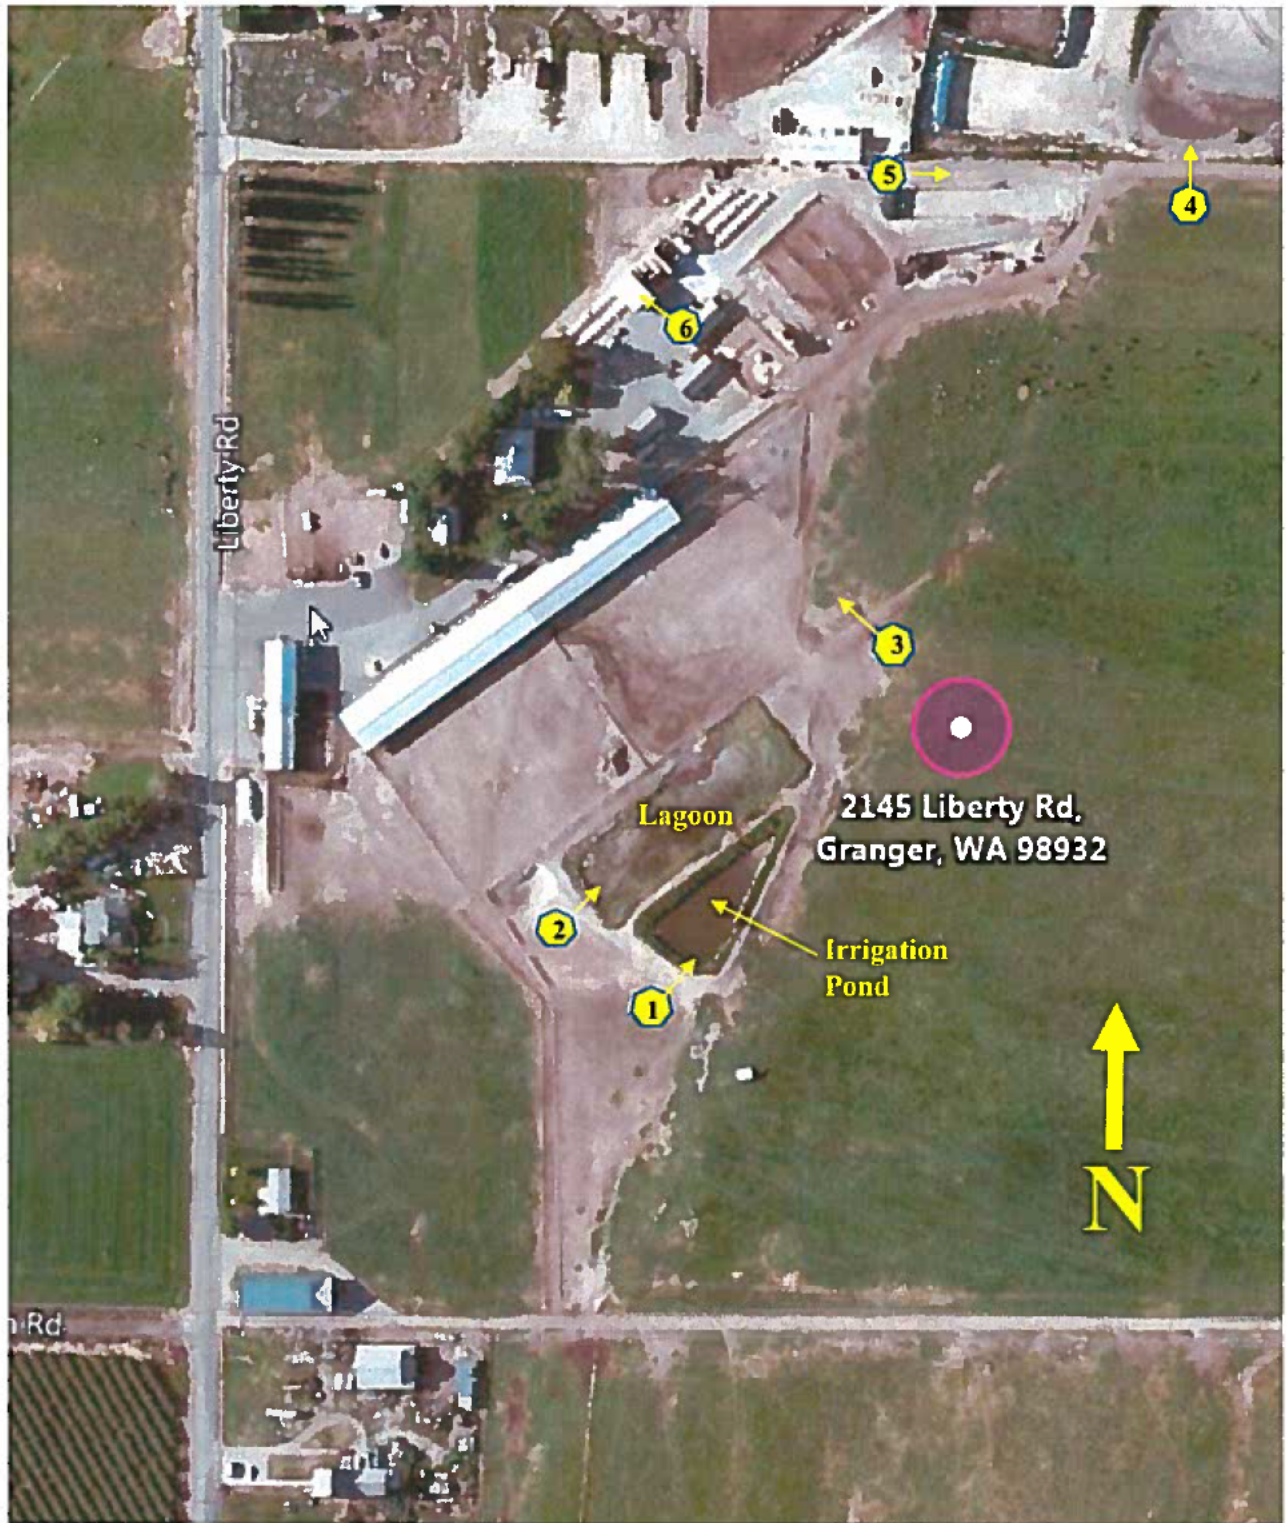
Pride & Joy Dairy #1

This Attachment includes an aerial image of the facility. This aerial image contains hexagons (⬡➔) which identify the approximate location of the photographer where certain Photograph Documentation photographs were taken. The number within the hexagon corresponds with the Photograph Documentation photo number. The arrow attached to the hexagon indicates the direction of the photograph.

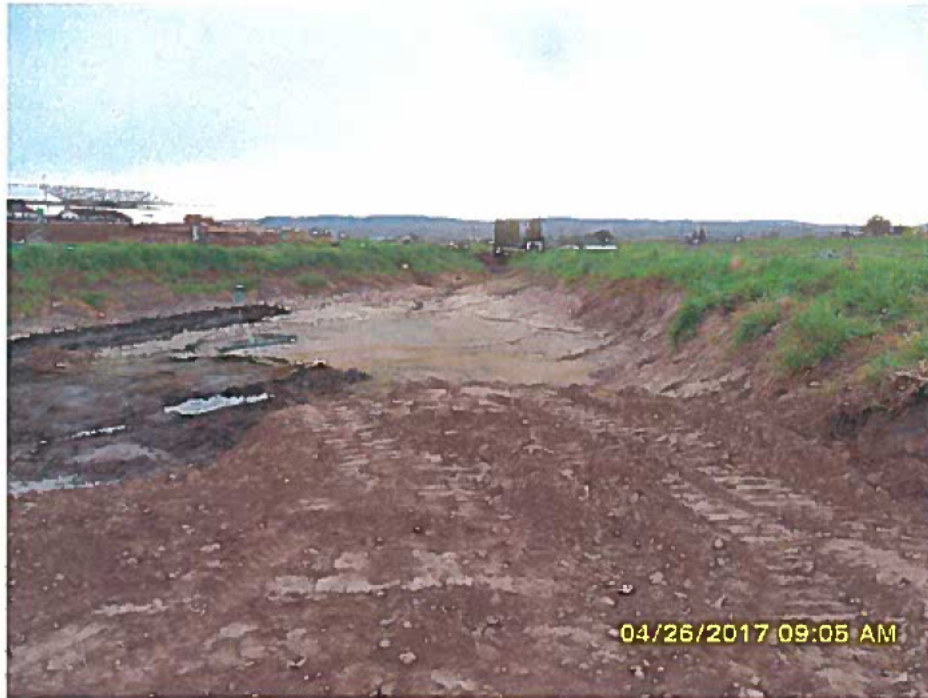
Photo #1: Northeasterly view showing the irrigation pond. This pond is used to mix irrigation water and manure water from the lagoon. This mixture is then land applied using sprinklers (pivot and wheel line). Camera photograph #SAM 2752.

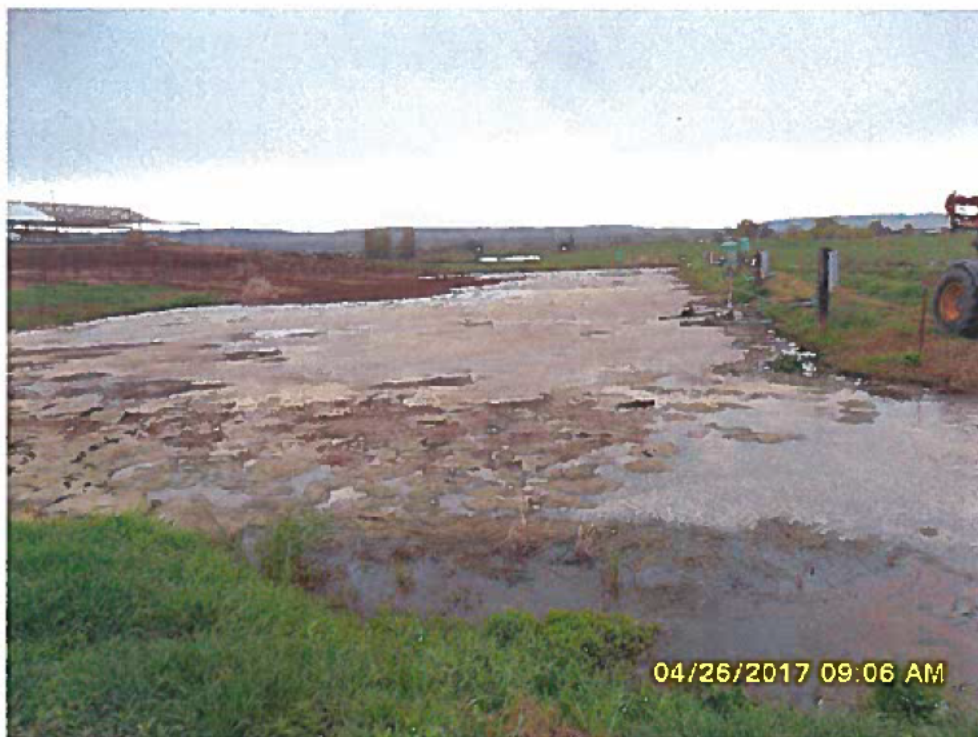
Photo #2: Northeasterly view of the manure lagoon. Camera photograph #SAM 2753.

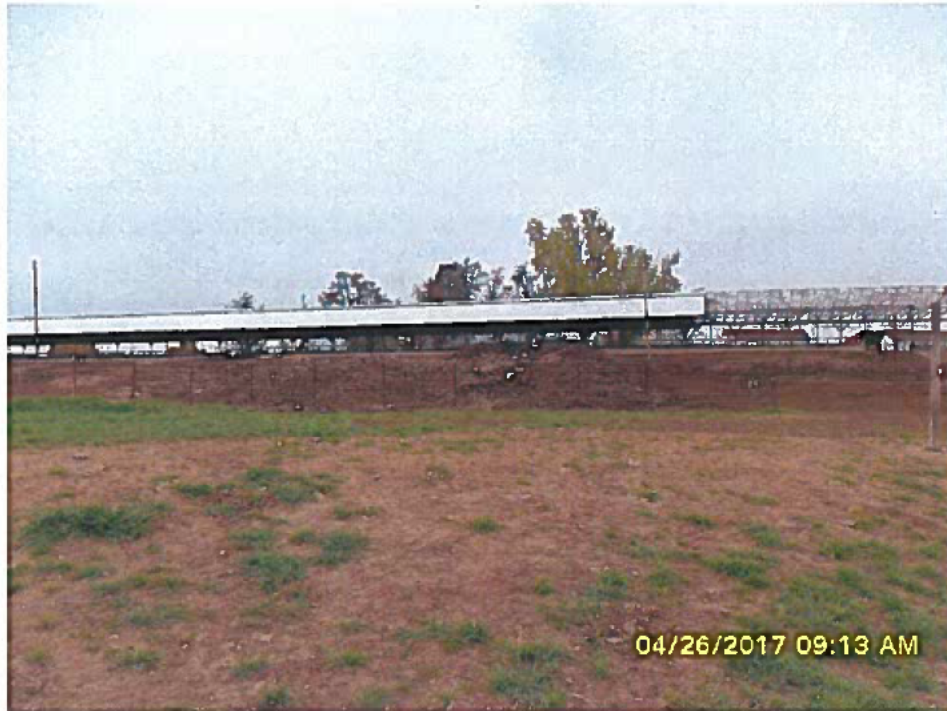
Photo #3: Northwesterly view showing a portion of the confinement area at the facility. Camera photograph #SAM 2754.

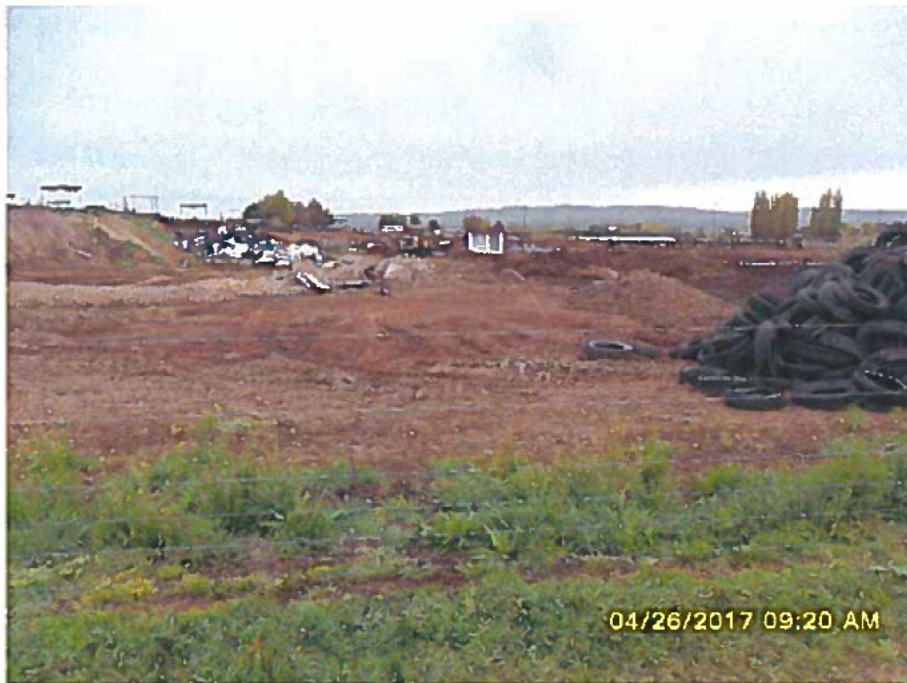
Photo #4: Northerly view showing a catch basin on Majestic Farms (a neighboring dairy operation) from the northern property boundary of Pride and Joy Dairy. Camera photograph #SAM 2755.

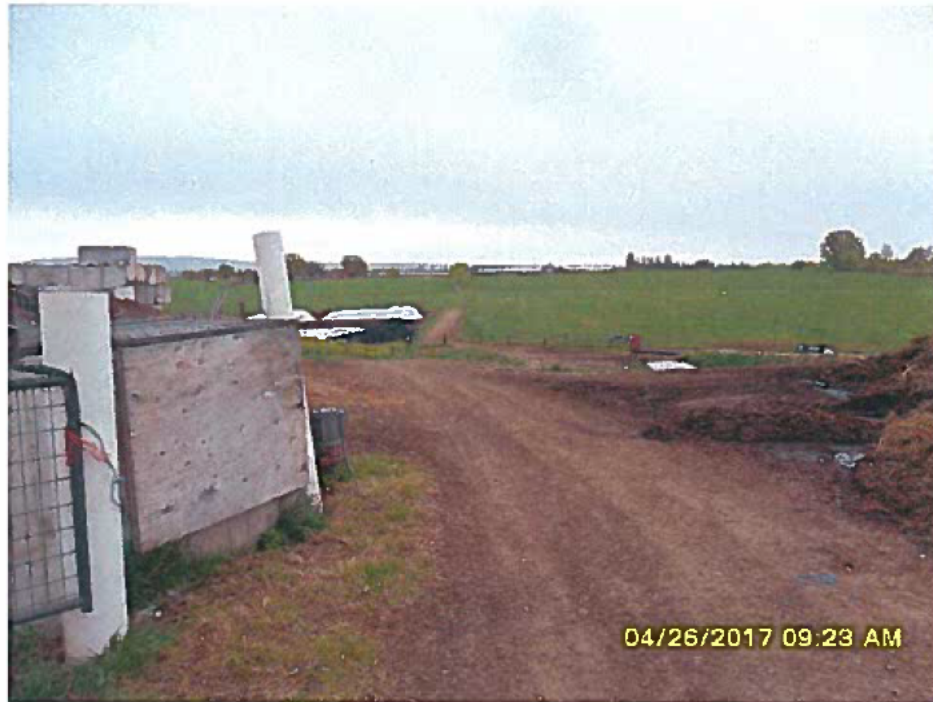
Photo #5: Easterly view of the border between Majestic Farms on the left and Pride and Joy Dairy on the right. Camera photograph #SAM 2756.

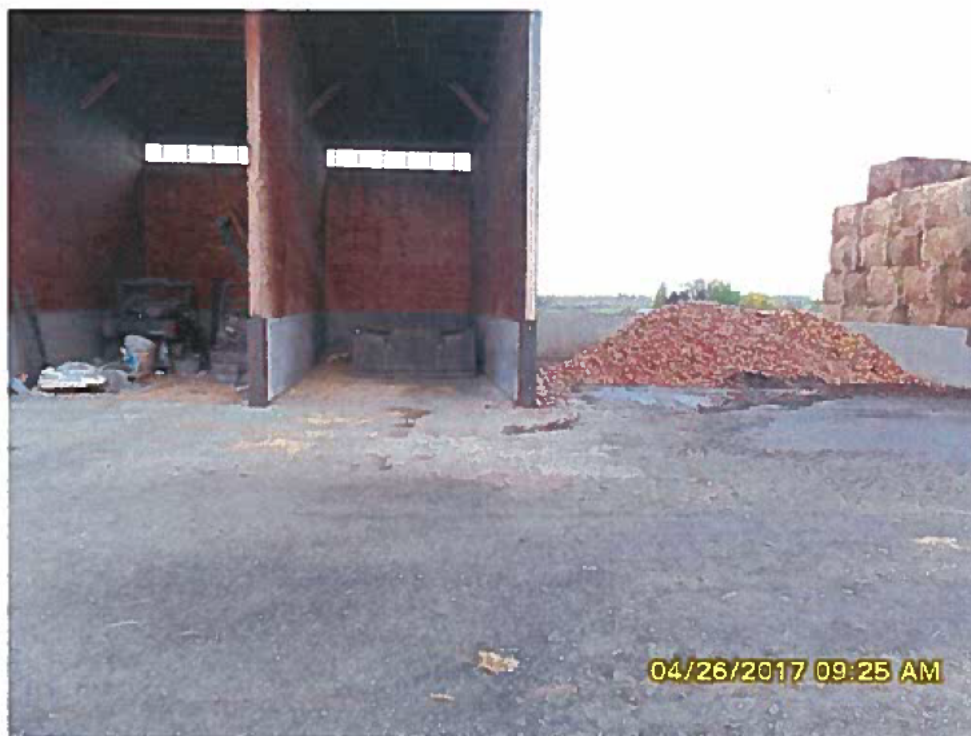
Photo #6: Northwesterly view showing the commodity storage area. Camera photograph #SAM 2757.
